**Flood Control Project Maintenance
Levee Inspections**

Fall 2016 Levee Maintenance Deficiency Summary Report

San Joaquin River Basin

Reclamation District No. 2058 Pescadero

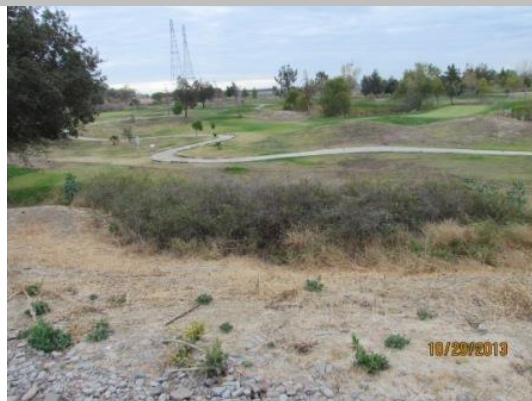
Photo 1 of 1 : FA_2016_RD2058_111_4_20160914_00004.jpg

LM Start	0.23	Rating **	A/W	Issue No.	4
LM End	0.23	Issue Type +	Ob	Location *	LS
Category	Earthen Levee			GPS Latitude/Longitude	
				Start	End
Item	Vegetation			37.804351 °	37.804351 °
				-121.418433 °	-121.418433 °
DWR ID	DWR_RD2058_01_f_2013_4				
Comment Code					
V8 : Environmental Requirements.					
Inspector Comment					
Wild rose on the levee. This area is riparian rabbit habitat.

View of the wild rose habitat for the brush rabbit.

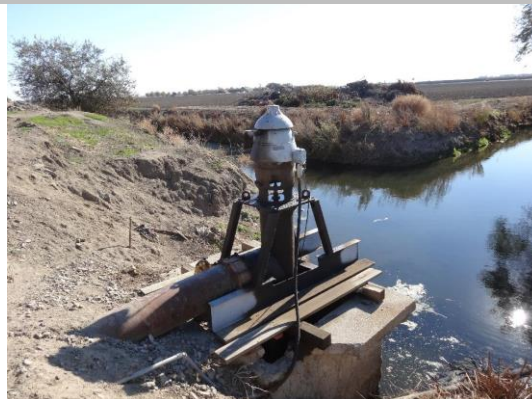
Photo 1 of 2 : UCIP_FA_2016_45843_45165.jpg

FS_ID:45843
DS_ID:22700
EP_NO: 5055
Repair Type: Non-Urgent
Crossing Status: Found
UCIP Comments: Excessive oil leakage.
FIELD_STRUCT_DESC: 16-inch steel stormdrain pipe through levee 3.8 feet below crown. Pump on concrete sump on landside. Siphon breaker under protective cover on the waterward slope (Permit No. 5055, 1666).
FS Date: 5/12/2015

LS view: exposed pipe and vertical pump on concrete sump on drain ditch.

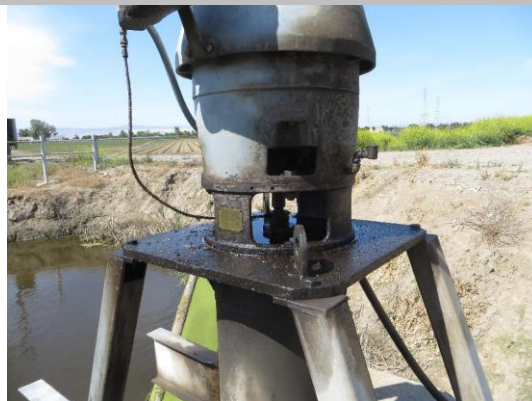
Photo 2 of 2 : UCIP_FA_2016_45843_74061.jpg

LS view: closeup of pump showing excessive oil leakage.

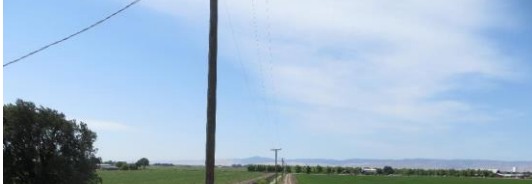
Photo 1 of 1 : UCIP_FA_2016_45847_74322.jpg

View of LS. Alignment of Crossing to right of canal at dirt access road.

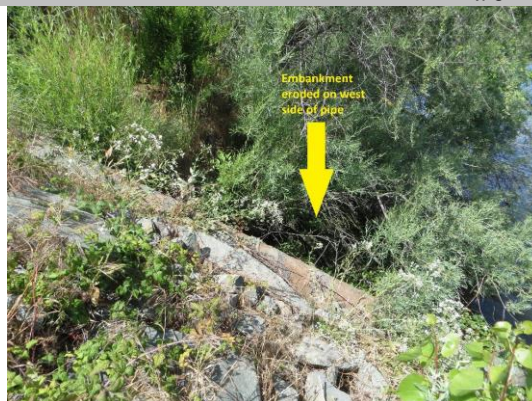
Photo 2 of 2 : UCIP_FA_2016_45850_74100.jpg

LM Start	1.22	Rating **	U	Issue No.	978 (cont)
LM End	1.22	Issue Type +	En	Location *	LS
Category	Supplemental			GPS Latitude/Longitude	
				Start	End
Item	DWR UCIP Field Study			37.802301 °	37.802301 °
				-121.401977 °	-121.401977 °
DWR ID					
Comment Code					
Inspector Comment					
FS_ID:45850 DS_ID:22694 EP_NO: 11546 Repair Type: Urgent Crossing Status: Found UCIP Comments: Erosion on west side of pipe at W/S toe. FIELD_STRUCT_DESC: 18-inch steel stormdrain pipe through the levee 2-feet below the crown. Pump in ditch on the landward side. Siphon breaker on waterside shoulder. Electrical service pole at the landward toe. Permit No. 11546, 1976. FS Date: 5/13/2015

WS view: slope on west side of pipe eroded at W/S toe. slope on east side of pipe OK.

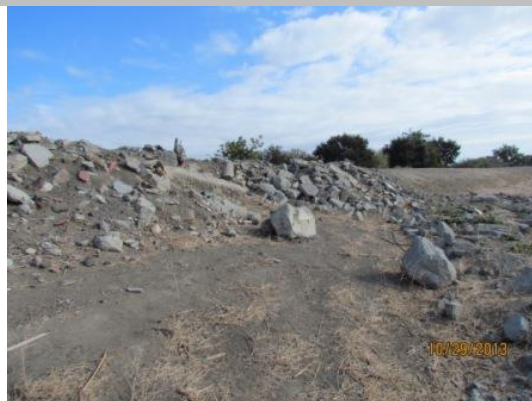
Photo 1 of 1 : FA_2016_RD2058_111_11_20160914_00005.jpg

LM Start	1.82	Rating **	U	Issue No.	11
LM End	1.83	Issue Type +	Ma	Location *	LS
Category	Earthen Levee			GPS Latitude/Longitude	
				Start	End
Item	Encroachments			37.804785 °	37.804802 °
				-121.391524 °	-121.391304 °
DWR ID	DWR_RD2058_01_f_2013_11				
Comment Code					
MA : Material					
Inspector Comment					
Pile of concrete contains rebar on landside slope obstructing visibility and access.

View of the concrete with rebar placed on the landside slope.

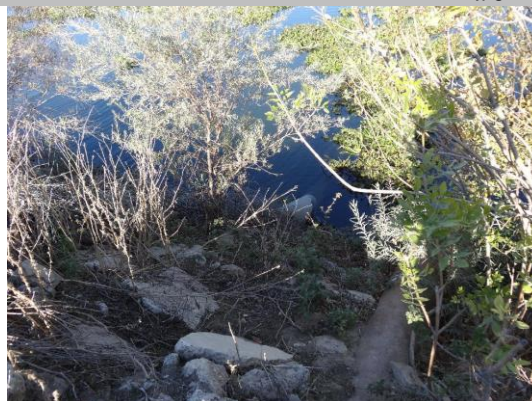
Photo 1 of 2 : UCIP_FA_2016_46770_45192.jpg

LM Start	2.12	Rating **	M	Issue No.	975
LM End	2.12	Issue Type +	En	Location *	LS
Category	Supplemental			GPS Latitude/Longitude	
				Start	End
Item	DWR UCIP Field Study			37.803886 °	37.803886 °
				-121.386271 °	-121.386271 °
DWR ID					
Comment Code					
Inspector Comment					
FS_ID:46770 DS_ID:22706 EP_NO: N/A Repair Type: Non-Urgent Crossing Status: Found UCIP Comments: Leaky and damaged siphon breaker on waterside shoulder. Update: leaky siphon breaker at LM 2.14 repaired per Spring 2015 Inspection Report. Need to confirm repair was done at this location. FIELD_STRUCT_DESC: 16-inch steel stormdrain pipe 8.0-feet below the crown. Siphon Breaker on waterward shoulder. Pump on concrete sump on landside. Originally included in the 1964 O&M manual, SJR 10, March 1964. FS Date: 5/13/2015

WS view: exposed steel pipe (right) on channel bank.

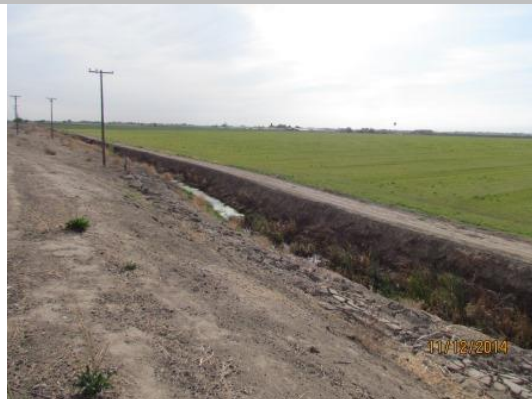
Photo 1 of 1 : FA_2016_RD2058_111_12_20160914_00006.jpg

LM Start	2.24	Rating **	M	Issue No.	12
LM End	2.30	Issue Type +	En	Location *	LS
Category	Earthen Levee			GPS Latitude/Longitude	
				Start	End
Item	Encroachments			37.803375 °	37.803136 °
				-121.384196 °	-121.383078 °
DWR ID	DWR_RD2058_01_f_2013_12				
Comment Code					
DT : Ditch					
Inspector Comment

View of the ditch at the landside levee toe.

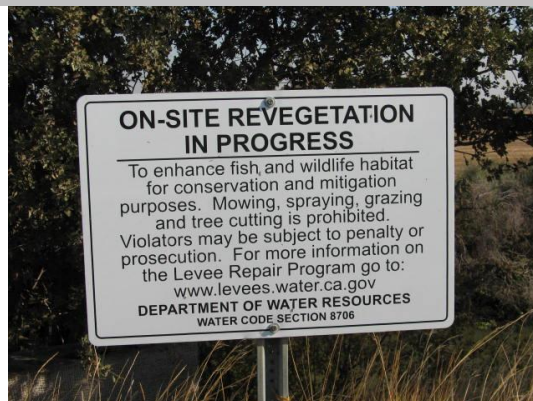
Photo 1 of 1 : FA_2016_RD2058_111_20_20160914_00009.jpg

LM Start	3.80	Rating **	A/W	Issue No.	20
LM End	3.85	Issue Type +	Ob	Location *	WS
Category	Earthen Levee			GPS Latitude/Longitude	
				Start	End
Item	Vegetation			37.790807 °	37.790088 °
				-121.362905 °	-121.362460 °
DWR ID	DWR_RD2058_01_s_2012_20				
Comment Code					
V8 : Environmental Requirements.					
Inspector Comment					
Revegetation site.

11/08/2011 Revegetation site, cannot trim or cut vegetation in this area.

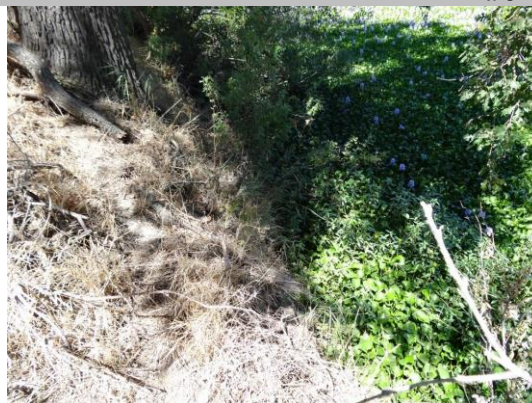
Photo 1 of 3 : SJR2016_RD2058U01RM3.97_1.jpg

Comment Code					
Inspector Comment					
07/20/2016: No significant change observed.					
08/04/2015: No significant change observed.					
08/26/2014: No significant change observed.					
08/28/2013: No significant change observed.					
07/26/2012: The site has been visited, and no significant change has been observed.					
09/02/2011: This site was not visited due to the time limit.					
09/22/2010: No significant change observed. Minor pocket erosions are lined at the lower bank. Two large Oak and Willow trees are on mid-slope and bench. The remaining bench was re-measured and found to be approximately 10 feet. There was no indication of active erosion on site during the site visit.					
08/05/2010: Recommended for annual assessment and monitoring of the site during flood events, per CLRO.					
07/23/2009: No major change observed since last visit; site is a 200-ft. long near-vertical berm erosion; recommend annual assessment and monitoring of the erosion site, per CLRO CES Evaluation 2008 Report; Site # is the same site previously reported as RM4.0,LM4.51; previously rated "U".

09/10/2008: Two large trees (2-3' DBH) with partial roots exposed.					
2007: Visited site 03/13/2007. [2016 Site ID:RD2058U01RM3.97]

Direct view of the pocket erosion site.

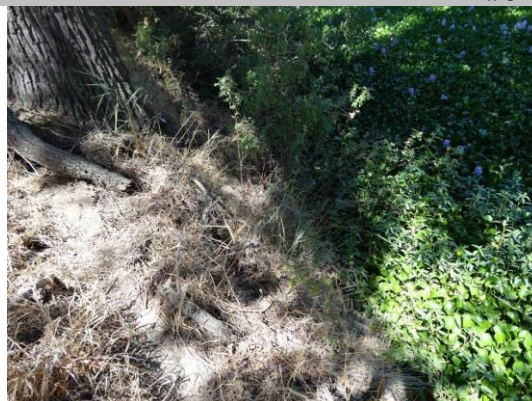
Photo 2 of 3 : SJR2016_RD2058U01RM3.97_2.jpg

Direct view of the erosion near a tree. Note the dense vegetation.

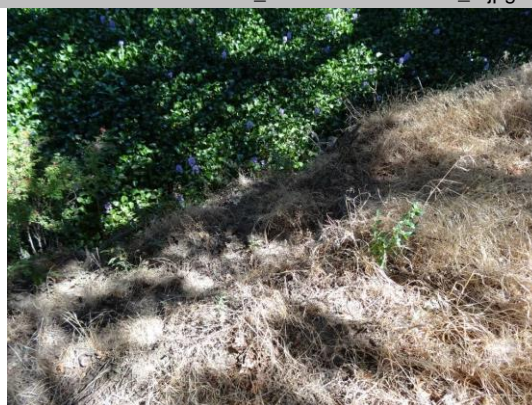
Photo 3 of 3 : SJR2016_RD2058U01RM3.97_4.jpg

Direct view of the erosion near a tree.

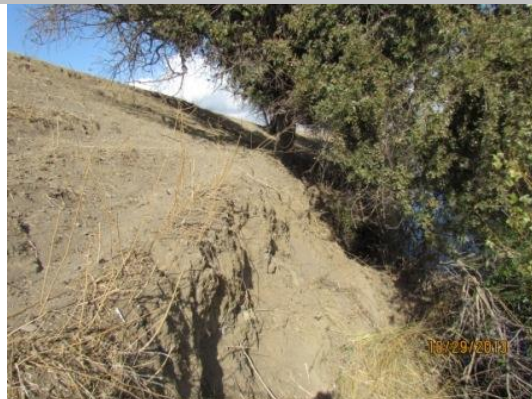
Photo 1 of 1 : FA_2016_RD2058_111_15_20160914_00007.jpg

LM Start	4.77	Rating **	U	Issue No.	15
LM End	4.77	Issue Type +	Ma	Location *	WS
Category	Earthen Levee			GPS Latitude/Longitude	
				Start	End
Item	Erosion / Bank Caving			37.785862 °	37.785862 °
				-121.350303 °	-121.350303 °
DWR ID	DWR_RD2058_01_f_2013_15				
Comment Code					
E1 : Note and monitor erosion site.					
Inspector Comment					
The erosion has about a 3 foot vertical cut at the waterside levee toe.

View of the erosion at the waterside levee toe.

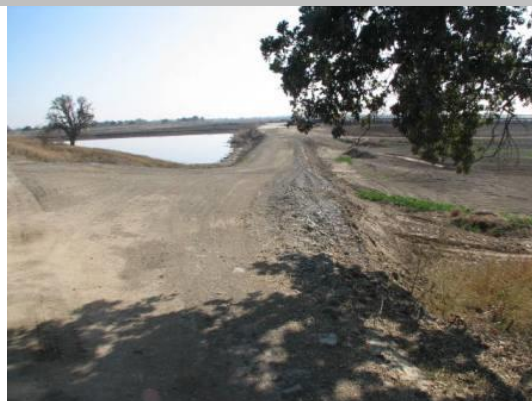
Photo 1 of 3 : FA_2016_RD2058_111_29_20160914_00013.jpg

LM Start	5.10	Rating **	U	Issue No.	29
LM End	5.10	Issue Type +	En	Location *	LS
Category	Earthen Levee			GPS Latitude/Longitude	
				Start	End
Item	Encroachments			37.783102 °	37.783102 °
				-121.345682 °	-121.345682 °
DWR ID	DWR_RD2058_01_s_2012_29				
Comment Code					
RA : Ramp					
Inspector Comment					
New ramp construction connecting dairy to levee. Construction of ramp results in a new pond on the landside of the levee. 2/21/2012, owner has said that he will contact the CVFPB to resolve this issue.

11/08/2011 New ramp has been constructed by Dairy farmer connecting his barns to the levee.

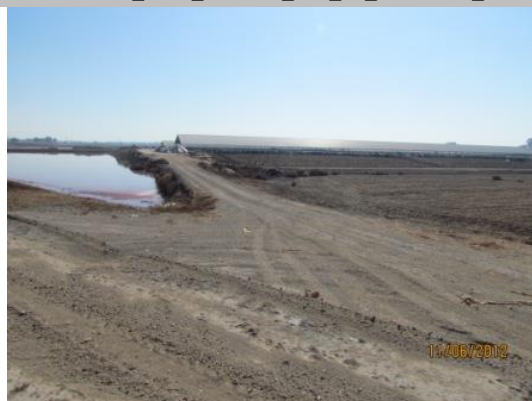
Photo 2 of 3 : FA_2016_RD2058_111_29_20160914_00014.jpg

Completed new ramp constructed by Dairy farmer connecting his barns to the levee.

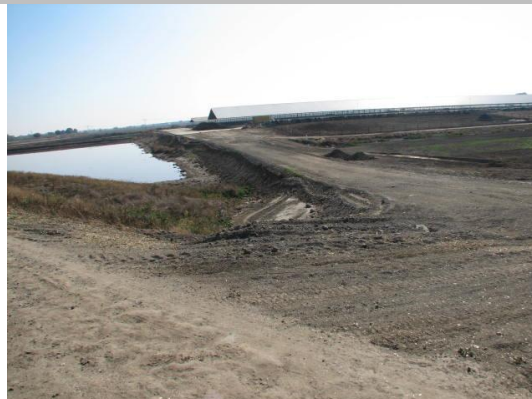
Photo 3 of 3 : FA_2016_RD2058_111_29_20160914_00015.jpg

LM Start	5.10	Rating **	U	Issue No.	29 (cont)	
LM End	5.10	Issue Type +	En	Location *	LS	
Category	Earthen Levee			GPS Latitude/Longitude		
				Start		End
Item	Encroachments			37.783102 °	37.783102 °	
				-121.345682 °	-121.345682 °	
DWR ID	DWR_RD2058_01_s _ 2012_29					
Comment Code						
RA : Ramp						
Inspector Comment						
New ramp construction connecting dairy to levee. Construction of ramp results in a new pond on the landside of the levee. 2/21/2012, owner has said that he will contact the CVFPB to resolve this issue.

11/08/2011 New ramp has been constructed by Dairy farmer connecting his barns to the levee.

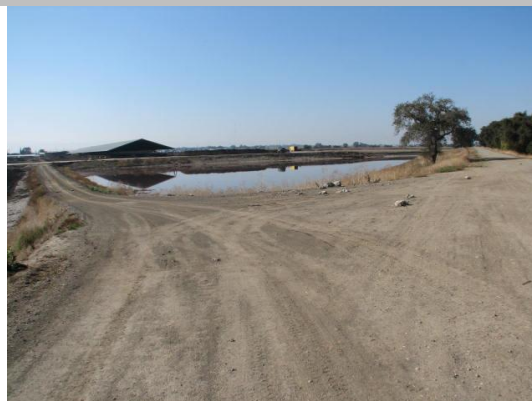
Photo 1 of 3 : FA_2016_RD2058_111_30_20160914_00016.jpg

LM Start	5.29	Rating **	U	Issue No.	30
LM End	5.29	Issue Type +	En	Location *	LS
Category	Earthen Levee			GPS Latitude/Longitude	
				Start	End
Item	Encroachments			37.782268 °	37.782268 °
				-121.342257 °	-121.342257 °
DWR ID	DWR_RD2058_01_s _ 2012_30				
Comment Code					
RA : Ramp					
Inspector Comment					
Ramp constructed to dairy. Raised ramps, see issue 29 are creating new holding ponds for dairy at levee toe.

11/08/2011 Photo shows existing middle ramp to the levee which has been raised.

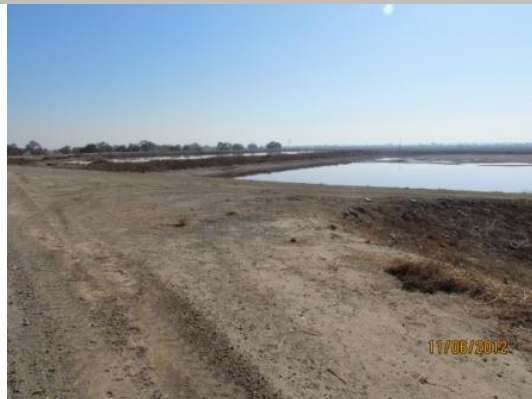
Photo 2 of 3 : FA_2016_RD2058_111_30_20160914_00017.jpg

LM Start	5.29	Rating **	U	Issue No.	30 (cont)	
LM End	5.29	Issue Type +	En	Location *	LS	
Category	Earthen Levee			GPS Latitude/Longitude		
				Start	End	
Item	Encroachments			37.782268 °	37.782268 °	
				-121.342257 °	-121.342257 °	
DWR ID	DWR_RD2058_01_s_2012_30					
Comment Code						
RA : Ramp						
Inspector Comment						
Ramp constructed to dairy. Raised ramps, see issue 29 are creating new holding ponds for dairy at levee toe.

Completed new ramp constructed by Dairy farmer connecting his barns to the levee.

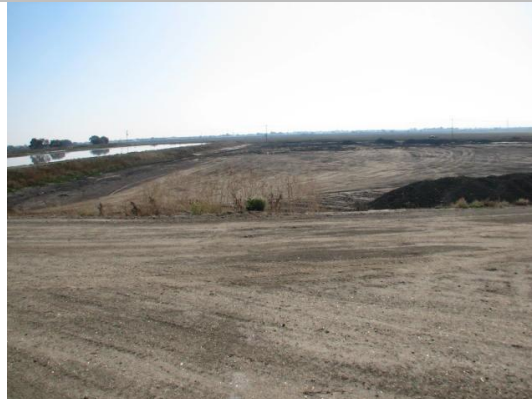
Photo 3 of 3 : FA_2016_RD2058_111_30_20160914_00018.jpg

11/08/2011 Photo shows view from the levee looking to the left of the middle ramp.

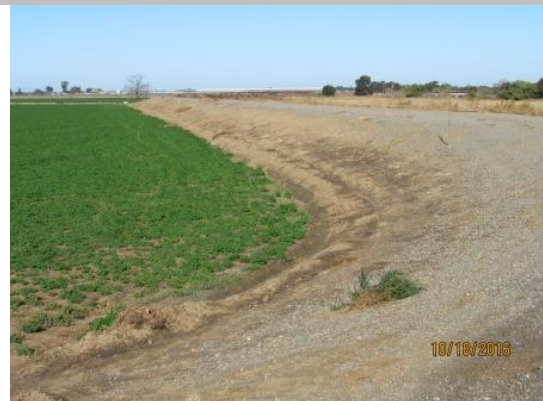
Photo 1 of 1 : FA_2016_RD2058_111_19_20161024_00038.jpg

View of the ditch at the landside levee toe.

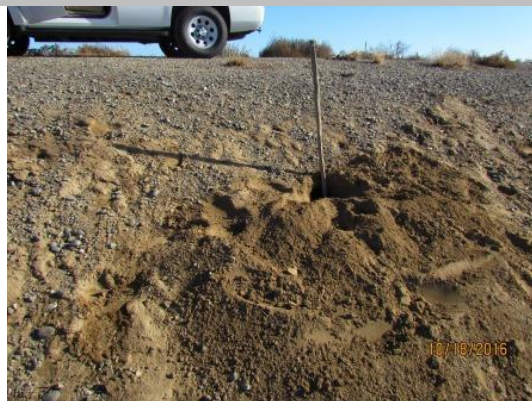
Photo 1 of 1 : FA_2016_RD2058_111_23_20161024_00041.jpg

LM Start	6.15	Rating **	M	Issue No.	23
LM End	6.15	Issue Type +	Ma	Location *	LS
Category	Earthen Levee			GPS Latitude/Longitude	
				Start	End
Item	Animal Control			37.773124 °	37.773124 °
				-121.332850 °	-121.332850 °
DWR ID	DWR_RD2058_01_f_2016_23				
Comment Code					
A3 : No rodents visible, but rodent burrows visible; need to backfill and compact or grout burrows.					
Inspector Comment

View of the rodent hole on the landside levee slope.

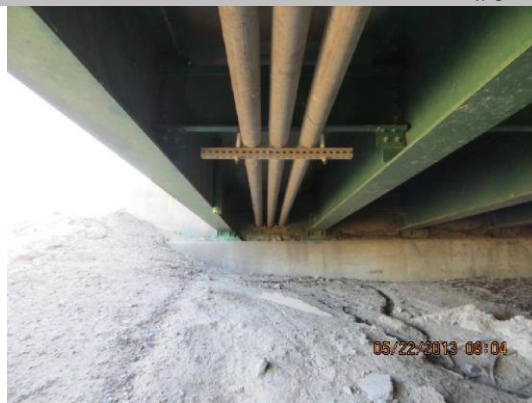
Photo 1 of 2 : UCIP_FA_2016_45871_73100.jpg

LM Start	6.46	Rating **	M	Issue No.	979
LM End	6.46	Issue Type +	En	Location *	LS
Category	Supplemental			GPS Latitude/Longitude	
				Start	End
Item	DWR UCIP Field Study			37.770158 °	37.770158 °
				-121.329430 °	-121.329430 °
DWR ID					
Comment Code					
Inspector Comment					
FS_ID:45871					
DS_ID:22701					
EP_NO: 13262					
Repair Type: Non-Urgent					
Crossing Status: Indicator Found					
UCIP Comments: Owner needs to install signs at crossing.					
FIELD_STRUCT_DESC: Three 4-inch communication conduits					
encased in concrete through levee 3.0 feet below crown (Permit No.					
13262, 1981). Sign on both banks of levee. Pipes visible under					
Manthey Rd Bridge at Paradise Cut.					
FS Date: 5/13/2015

Pipes visible under Manthey Rd Bridge at Paradise Cut.

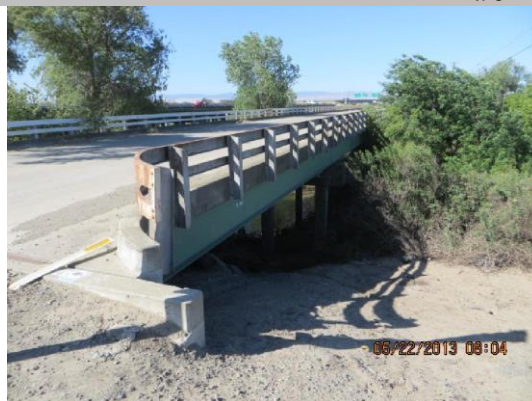
Photo 2 of 2 : UCIP_FA_2016_45871_73101.jpg

LM Start	6.46	Rating **	M	Issue No.	979 (cont)
LM End	6.46	Issue Type +	En	Location *	LS
Category	Supplemental			GPS Latitude/Longitude	
				Start	End
Item	DWR UCIP Field Study			37.770158 °	37.770158 °
				-121.329430 °	-121.329430 °
DWR ID					
Comment Code					
Inspector Comment					
FS_ID:45871 DS_ID:22701 EP_NO: 13262 Repair Type: Non-Urgent Crossing Status: Indicator Found UCIP Comments: Owner needs to install signs at crossing. FIELD_STRUCT_DESC: Three 4-inch communication conduits encased in concrete through levee 3.0 feet below crown (Permit No. 13262, 1981). Sign on both banks of levee. Pipes visible under Manthey Rd Bridge at Paradise Cut. FS Date: 5/13/2015

Pipes visible under Manthey Rd Bridge at Paradise Cut.

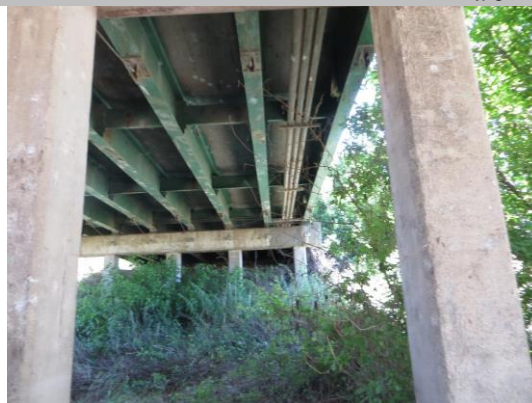
Photo 1 of 2 : UCIP_FA_2016_45768_74267.jpg

LM Start	6.46	Rating **	M	Issue No.	980
LM End	6.46	Issue Type +	En	Location *	LS
Category	Supplemental			GPS Latitude/Longitude	
				Start	End
Item	DWR UCIP Field Study			37.770159 °	37.770159 °
				-121.329426 °	-121.329426 °
DWR ID					
Comment Code					
Inspector Comment					
FS_ID:45768 DS_ID:25077 EP_NO: 13262 Repair Type: Non-Urgent Crossing Status: Indicator Found UCIP Comments: Owner needs to install signs at crossing. FIELD_STRUCT_DESC: 2 of 3: 4-inch communication conduit encased in concrete through levee 3.0 feet below crown. Sign on both banks of levee. Manhole on both sides of Manthey Rd at utility crossing. (Permit No. 13262, 1981) FS Date: 5/13/2015

Pipes visible under Manthey Rd Bridge at Paradise Cut

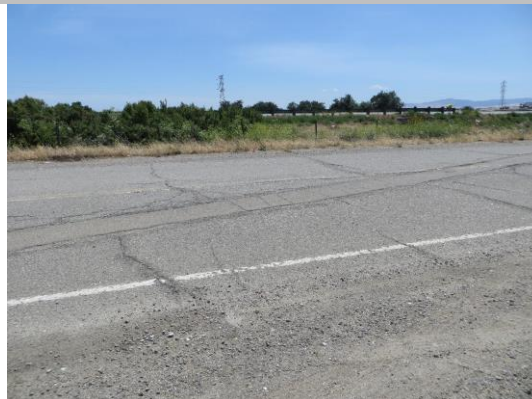
Photo 2 of 2 : UCIP_FA_2016_45768_74268.jpg

LM Start	6.46	Rating **	M	Issue No.	980 (cont)	
LM End	6.46	Issue Type +	En	Location *	LS	
Category	Supplemental			GPS Latitude/Longitude		
				Start	End	
Item	DWR UCIP Field Study			37.770159 °	37.770159 °	
				-121.329426 °	-121.329426 °	
DWR ID						
Comment Code						
Inspector Comment						
FS_ID:45768 DS_ID:25077 EP_NO: 13262 Repair Type: Non-Urgent Crossing Status: Indicator Found UCIP Comments: Owner needs to install signs at crossing. FIELD_STRUCT_DESC: 2 of 3: 4-inch communication conduit encased in concrete through levee 3.0 feet below crown. Sign on both banks of levee. Manhole on both sides of Manthey Rd at utility crossing. (Permit No. 13262, 1981) FS Date: 5/13/2015

Cuts in pavement visible appr. 450 ft from WS toe.

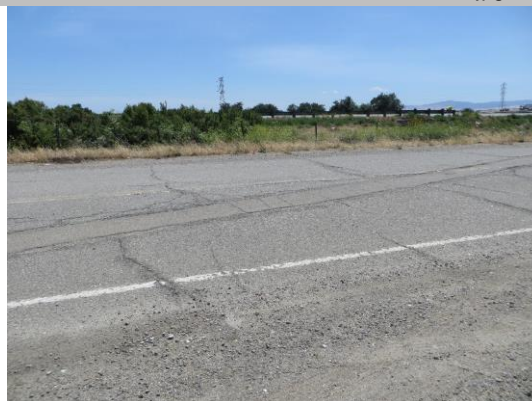
Photo 1 of 2 : UCIP_FA_2016_45769_74270.jpg

LM Start	6.46	Rating **	M	Issue No.	981
LM End	6.46	Issue Type +	En	Location *	LS
Category	Supplemental			GPS Latitude/Longitude	
				Start	End
Item	DWR UCIP Field Study			37.770158 °	37.770158 °
				-121.329430 °	-121.329430 °
DWR ID					
Comment Code					
Inspector Comment					
FS_ID:45769					
DS_ID:25078					
EP_NO: 13262					
Repair Type: Non-Urgent					
Crossing Status: Indicator Found					
UCIP Comments: Owner needs to install sign at crossing.					
FIELD_STRUCT_DESC: 3 of 3: 4-inch communication conduit encased					
in concrete through levee 3.0 feet below crown. Sign on both banks of					
levee. Manhole on both sides of Manthey Rd at utility crossing. (Permit					
No. 13262, 1981)					
FS Date: 5/13/2015

Cuts in pavement visible appr. 450 ft from WS toe.

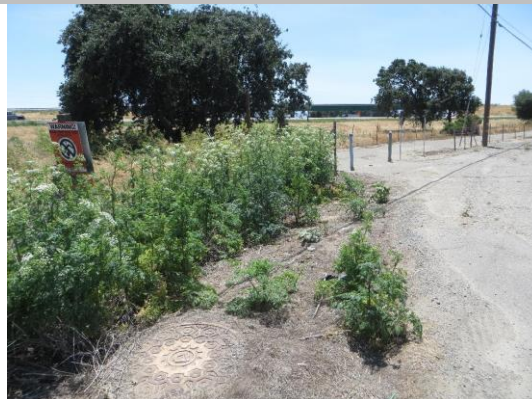
Photo 2 of 2 : UCIP_FA_2016_45769_74271.jpg

LM Start	6.46	Rating **	M	Issue No.	981 (cont)	
LM End	6.46	Issue Type +	En	Location *	LS	
Category	Supplemental			GPS Latitude/Longitude		
				Start	End	
Item	DWR UCIP Field Study			37.770158 °	37.770158 °	
				-121.329430 °	-121.329430 °	
DWR ID						
Comment Code						
Inspector Comment						
FS_ID:45769 DS_ID:25078 EP_NO: 13262 Repair Type: Non-Urgent Crossing Status: Indicator Found UCIP Comments: Owner needs to install sign at crossing. FIELD_STRUCT_DESC: 3 of 3: 4-inch communication conduit encased in concrete through levee 3.0 feet below crown. Sign on both banks of levee. Manhole on both sides of Manthey Rd at utility crossing. (Permit No. 13262, 1981) FS Date: 5/13/2015

Comm sign and Pac Bell manhole appr. 600 ft from LS toe.
